# Test and Evaluation Report

For the Greenspan EC3000 Conductivity/Temperature Sensor

Silver Spring, Maryland  
January 2013

### Test and Evaluation Report for the Greenspan EC3000 Conductivity/Temperature Sensor

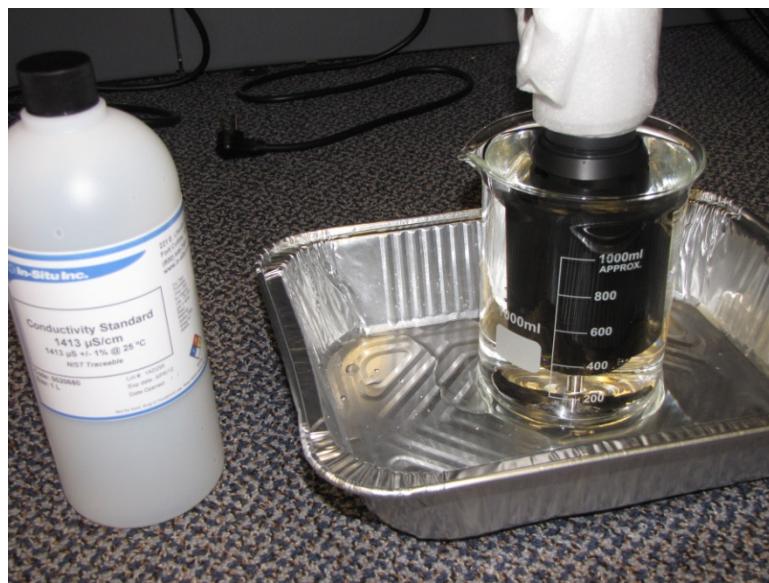
**Figure 1.** Greenspan CT sensor in conductivity calibration standard solution.

The laboratory calibration tests were carried out in two separate rounds. Given the limited container size, only one instrument could be tested at a time. In round one, the Greenspan was first placed into the fresh calibration standard solution (fig. 1). Following the period of equilibration (approximately 15 min) and data collection (approximately 30 min), the Greenspan was removed and the FSI was immediately placed in the solution. To confirm that there was no bias toward the first instrument placed in solution (from evaporation, for example), the Greenspan was placed back in solution during several different tests to ensure that its results had not drifted after the first test.

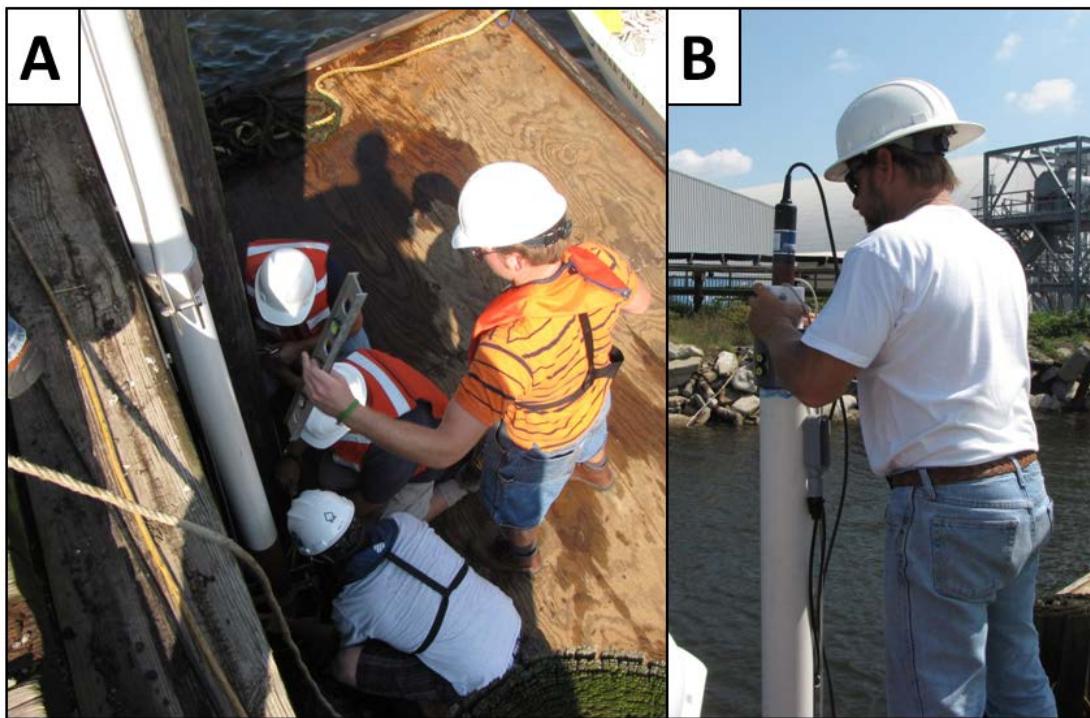
**Figure 14.** (A) CO-OPS personnel install the bottom bracket of the Money Point test CT well from a floating dock. (B) Installation of the Greenspan sensor into the top of the CT well from the pier.

The well and test Greenspan EC3000 CT sensor were installed at Money Point on 16 August 2012 (fig. 14). OSTEP personnel originally intended to install the sensor from CO-OPS' 16-ft Boston Whaler but instead moved an existing floating dock from the pier to the installation site, which greatly improved the ease of operations.
